# TREES, BUGS, DIRT

May 19, 2023

Subject: Evaluation of One Carob (*Ceratonia siliqua*) tree & Proposed New Landscaping in Pueblo Park

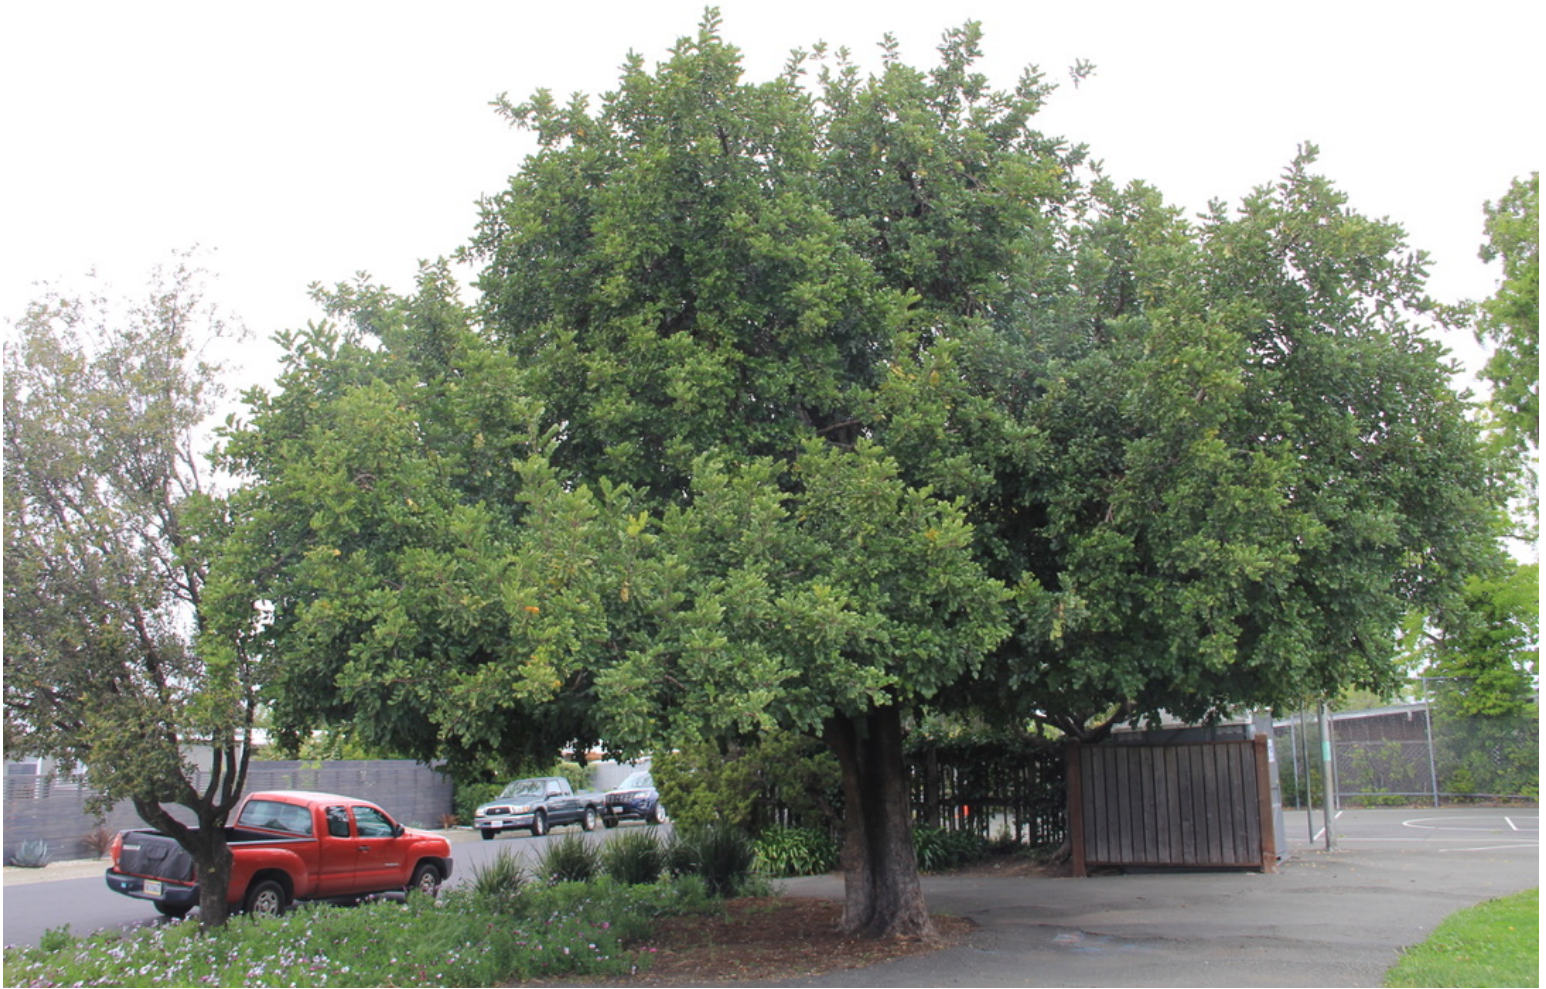
- Trunk circumference = 70 inches (22.3 inches in diameter)
- Tree height = 30 feet
- Health good, Structure fair, Form fair<sup>1</sup>
- +approximately 50% of rooting zone within dripline has limited root access due to asphalt paving (**H**), **pavement cracked & uplifted near tree within and beyond its dripline**

tree in question with visible uplifting of asphalt pavement nearby caused by roots

- Professionally air spade or hand trench along line of limits of work.
- Professionally prune roots using sharp tools along the line of limits of work.
- Install root barrier along edge of pruned roots that will serve to protect roots from new pavement material & slow new growth into pavement, options include a wide range of materials and products including plastic interlocking root barriers, steel plates, and cloth with slow release herbicide.
- If root barrier is not installed immediately after root pruning, place fill soil over pruned roots & cover with wet burlap, and then install a thin layer of plastic in between roots & new pavement material to prevent root damage from new pavement materials.

### CONSIDER PAVING OPTIONS THAT MAY REDUCE NEGATIVE IMPACTS TO TREE

- Rubber pavement
- Geocell, Silva Cell
- Structural soil

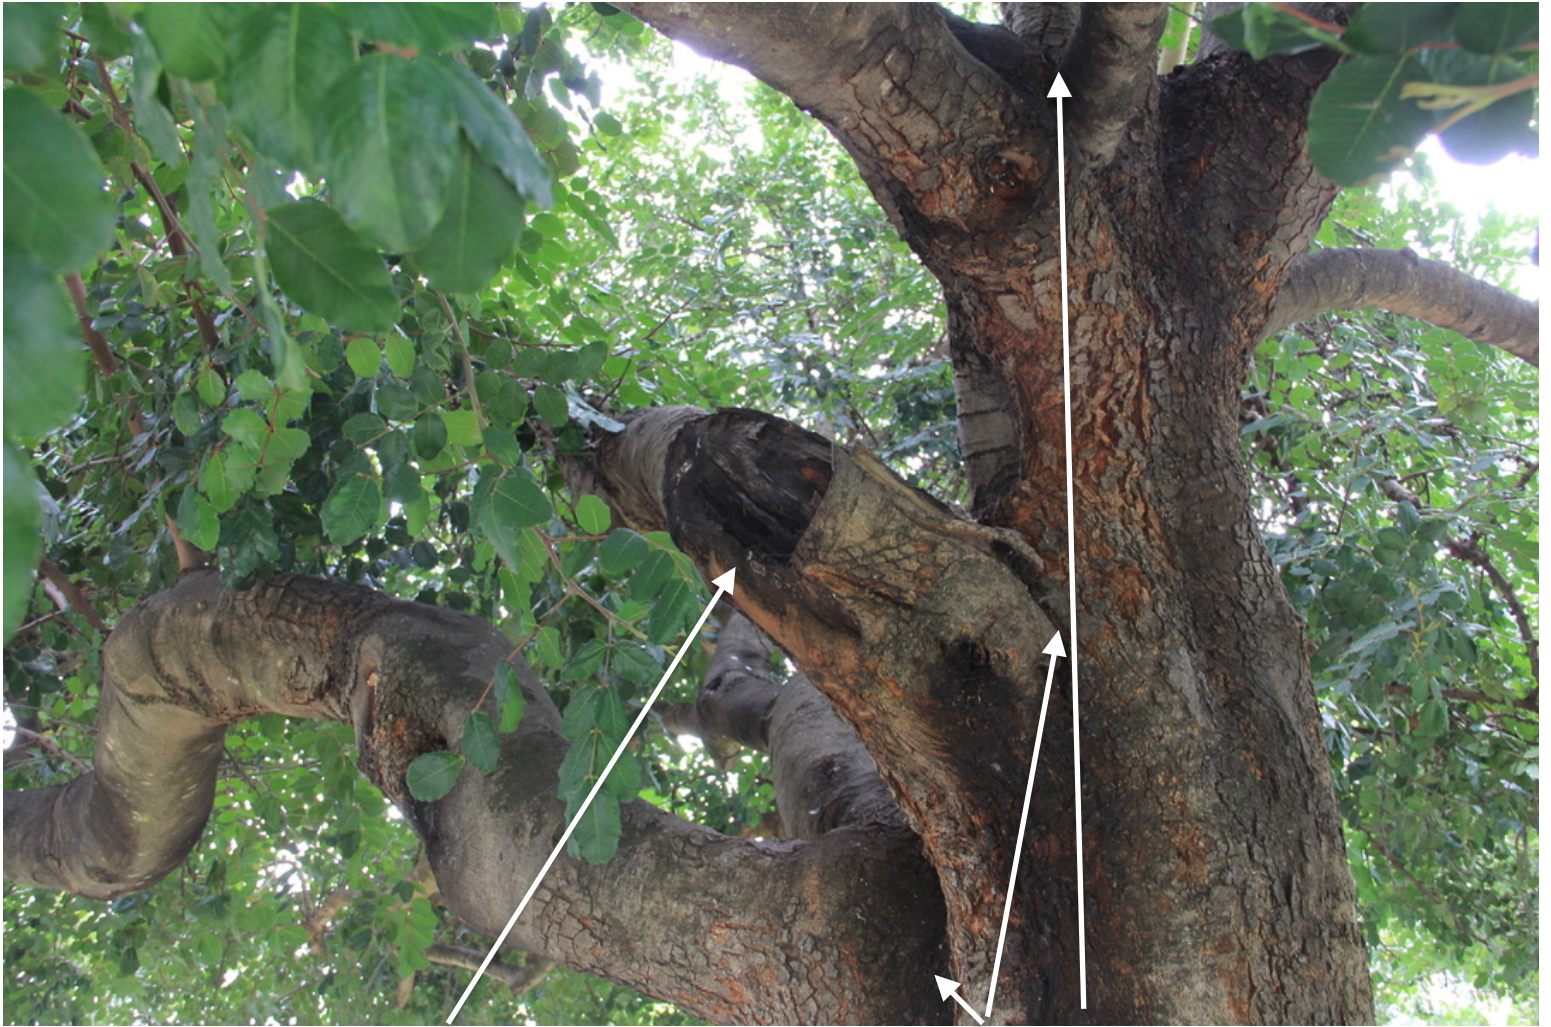
- +scaffold branches multiple, codominant, one split, large open wound near scaffold failure, strong growth response, multiple sunken flush cut wounds oozing(**S,F**)

torn scaffold branch with infection      weak included bark scaffold connections

- Prune
  - Natural pruning system
  - Reduce likelihood of branch failure by properly reducing branches 1-2" in diameter, not to exceed 15 branches removed
- Install chain-link fencing anchored in the soil around entire previous planting bed that tree is in.
- Install trunk protection on side facing pavement, either straw wattles wrapped up trunk, or 2"X4"X12' lumber strapped to trunk & covered with orange, plastic snow fencing.

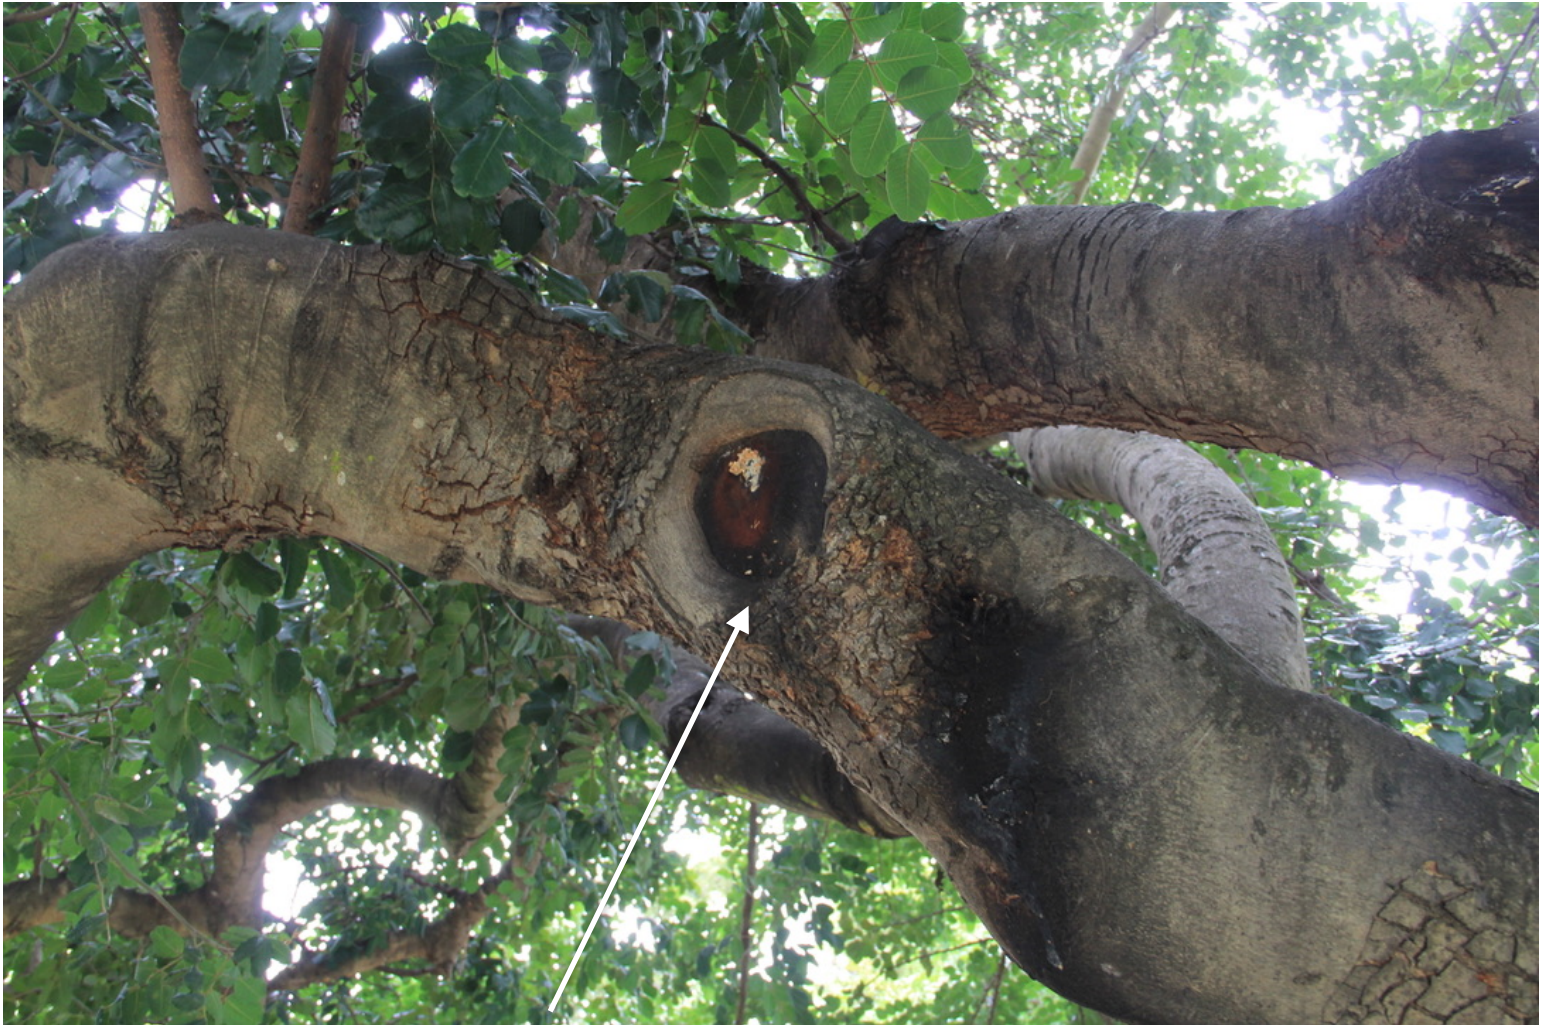
- +root crown region clear, pavement one foot from trunk (**H**)
- +trunk upright, not well tapered (**S,F**), multiple historic wounds from poor (flush) pruning cuts that are infected and oozing, sapsucker damage, some woundwood forming(**H,S**)

sunken historical flush cut with strong woundwood response, some disease infection also
