May 19, 2023

Subject: Evaluation of One Carob (*Ceratonia siliqua*) tree & Proposed New Landscaping in Pueblo Park

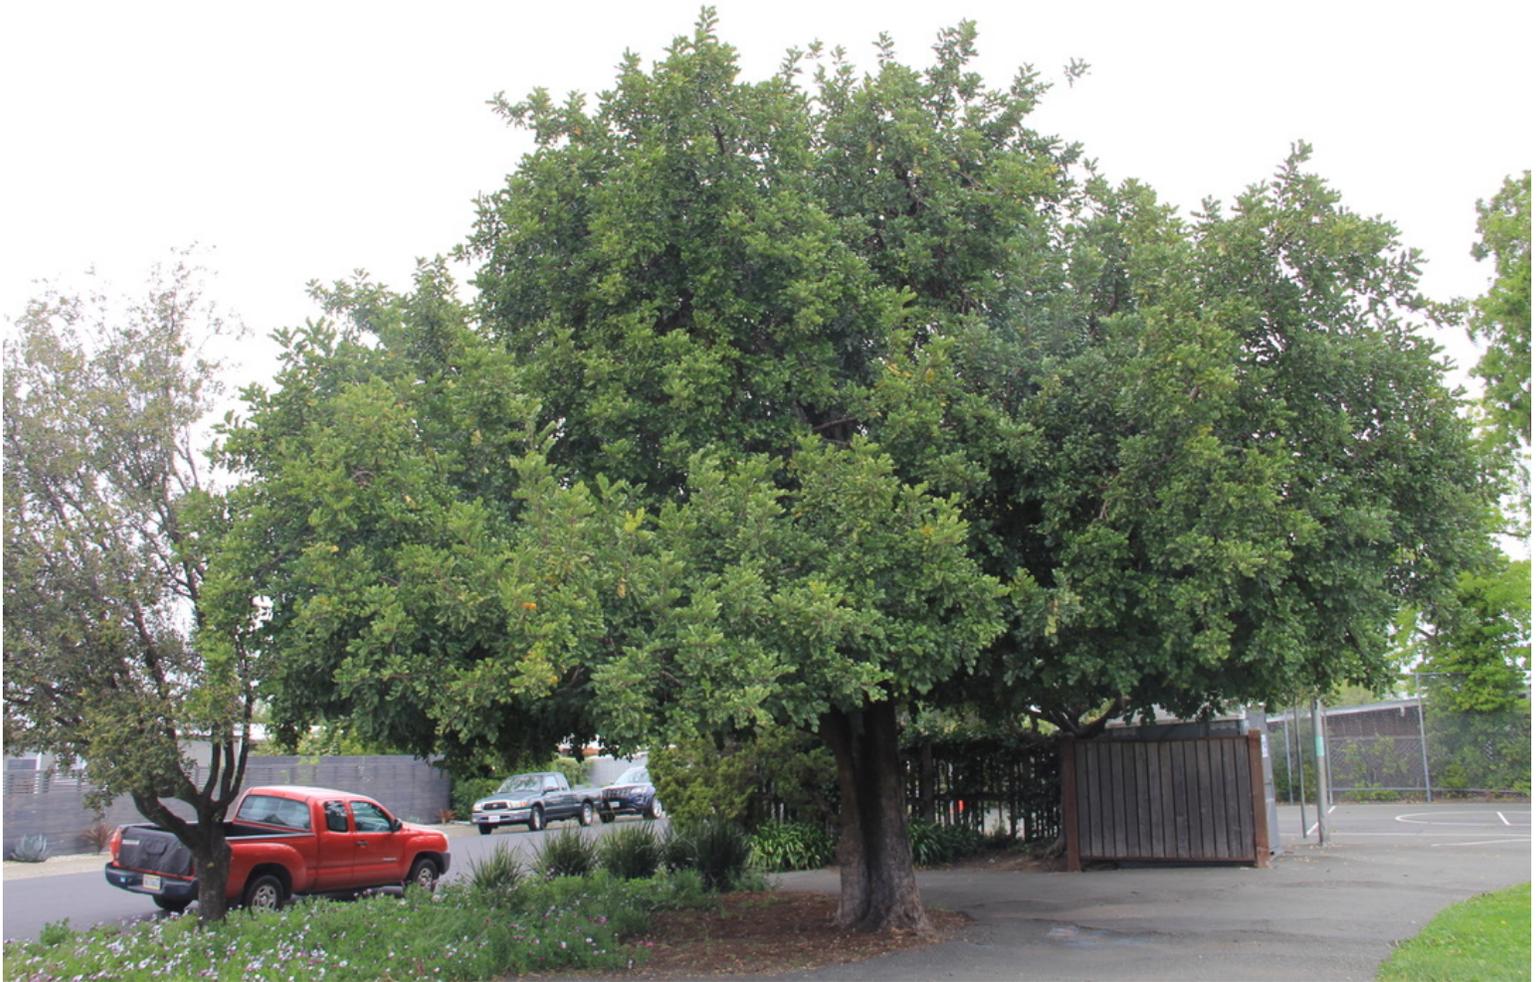
- Trunk circumference = 70 inches (22.3 inches in diameter)
- Tree height = 30 feet
- Health good, Structure fair, Form fair<sup>1</sup>
- +approximately 50% of rooting zone within dripline has limited root access due to asphalt paving (**H**), **pavement cracked & uplifted near tree within and beyond its dripline**

tree in question with visible uplifting of asphalt pavement nearby caused by roots

- Professionally air spade or hand trench along line of limits of work.
- Professionally prune roots using sharp tools along the line of limits of work.
- Install root barrier along edge of pruned roots that will serve to protect roots from new pavement material & slow new growth into pavement, options include a wide range of materials and products including plastic interlocking root barriers, steel plates, and cloth with slow release herbicide.
- If root barrier is not installed immediately after root pruning, place fill soil over pruned roots & cover with wet burlap, and then install a thin layer of plastic in between roots & new pavement material to prevent root damage from new pavement materials.

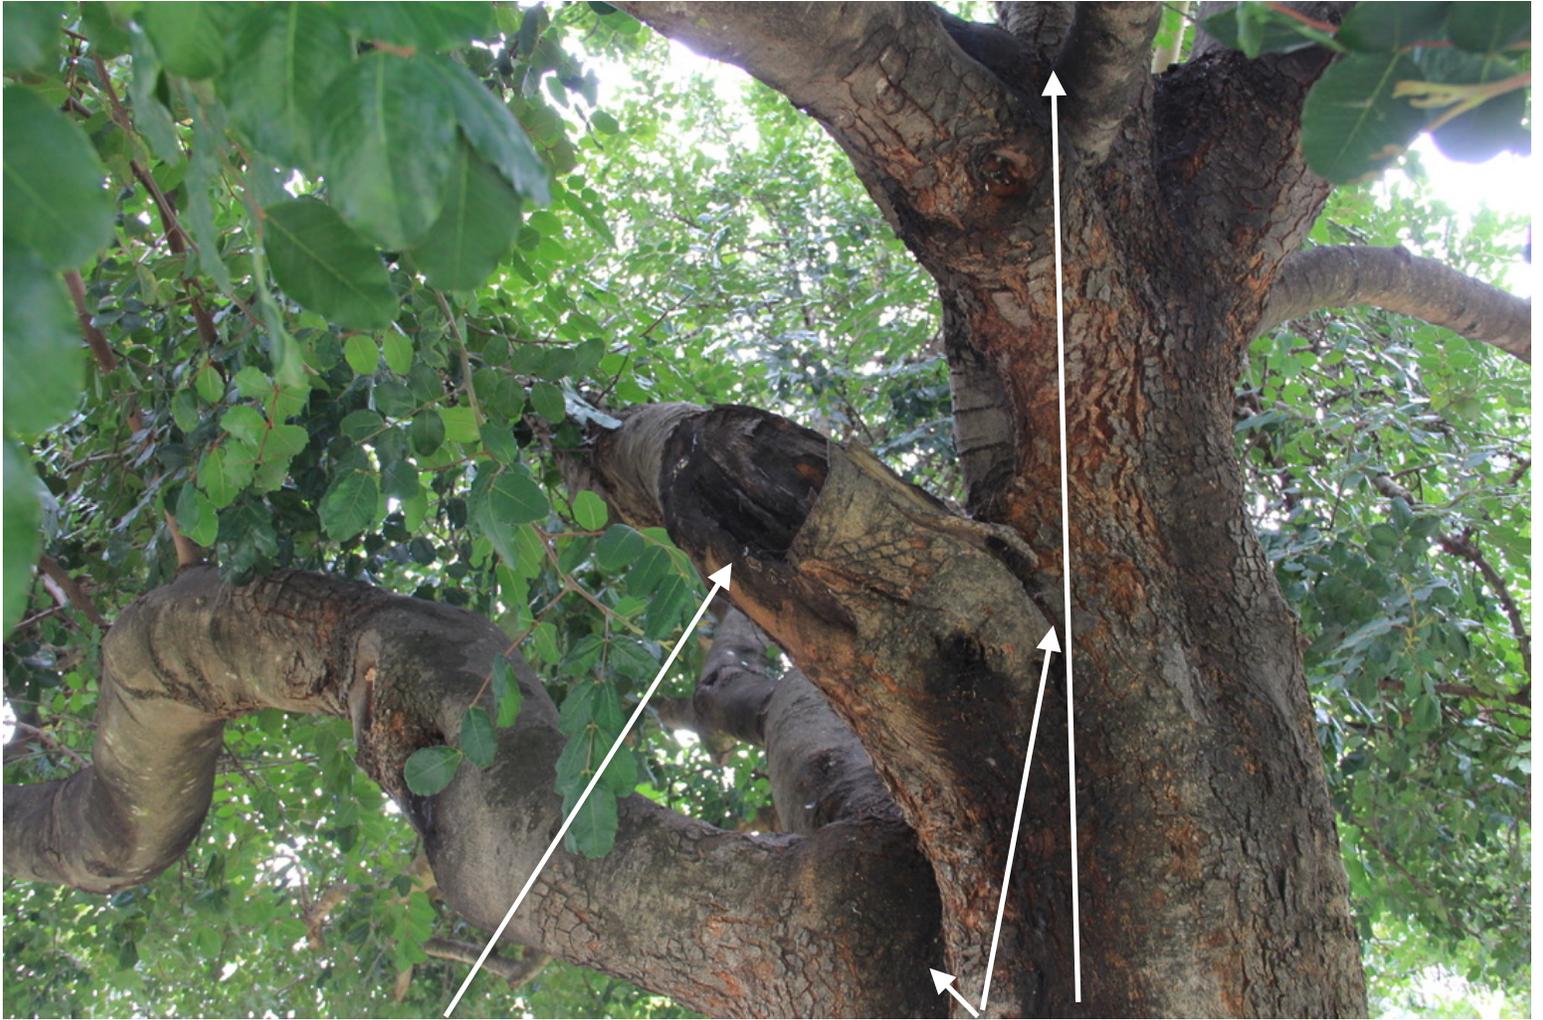
- +scaffold branches multiple, codominant, one split, large open wound near scaffold failure, strong growth response, multiple sunken flush cut wounds oozing(**S,F**)

torn scaffold branch with infection      weak included bark scaffold connections

- Prune
  - Natural pruning system
  - Reduce likelihood of branch failure by properly reducing branches 1-2" in diameter, not to exceed 15 branches removed
- Install chain-link fencing anchored in the soil around entire previous planting bed that tree is in.
- Install trunk protection on side facing pavement, either straw wattles wrapped up trunk, or 2"X4"X12' lumber strapped to trunk & covered with orange, plastic snow fencing.

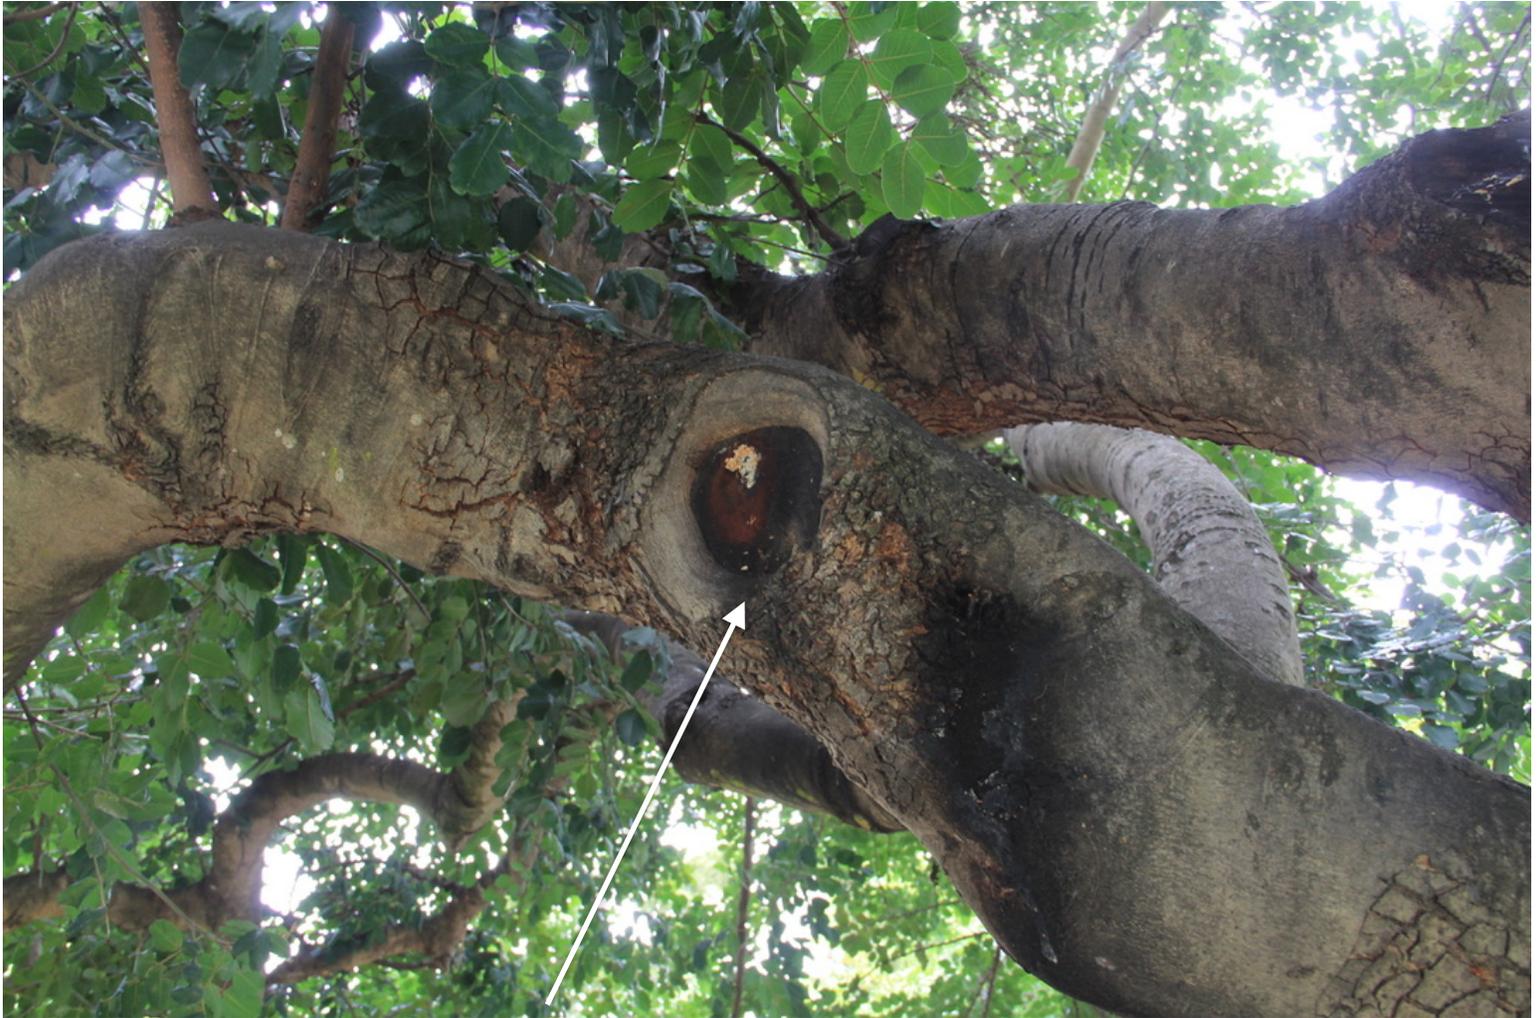
- +root crown region clear, pavement one foot from trunk (**H**)
- +trunk upright, not well tapered (**S,F**), multiple historic wounds from poor (flush) pruning cuts that are infected and oozing, sapsucker damage, some woundwood forming(**H,S**)

sunken historical flush cut with strong woundwood response, some disease infection also
